KENTUCKY PUBLIC SERVICE COMMISSION)	
)	
VS.)	CASE NO. 9671
)	
HARDIN COUNTY WATER DISTRICT NO. 1)

REPORT ON THE COLLAPSE OF A
HARDIN COUNTY WATER DISTRICT #1 STANDPIPE

February 7, 1986

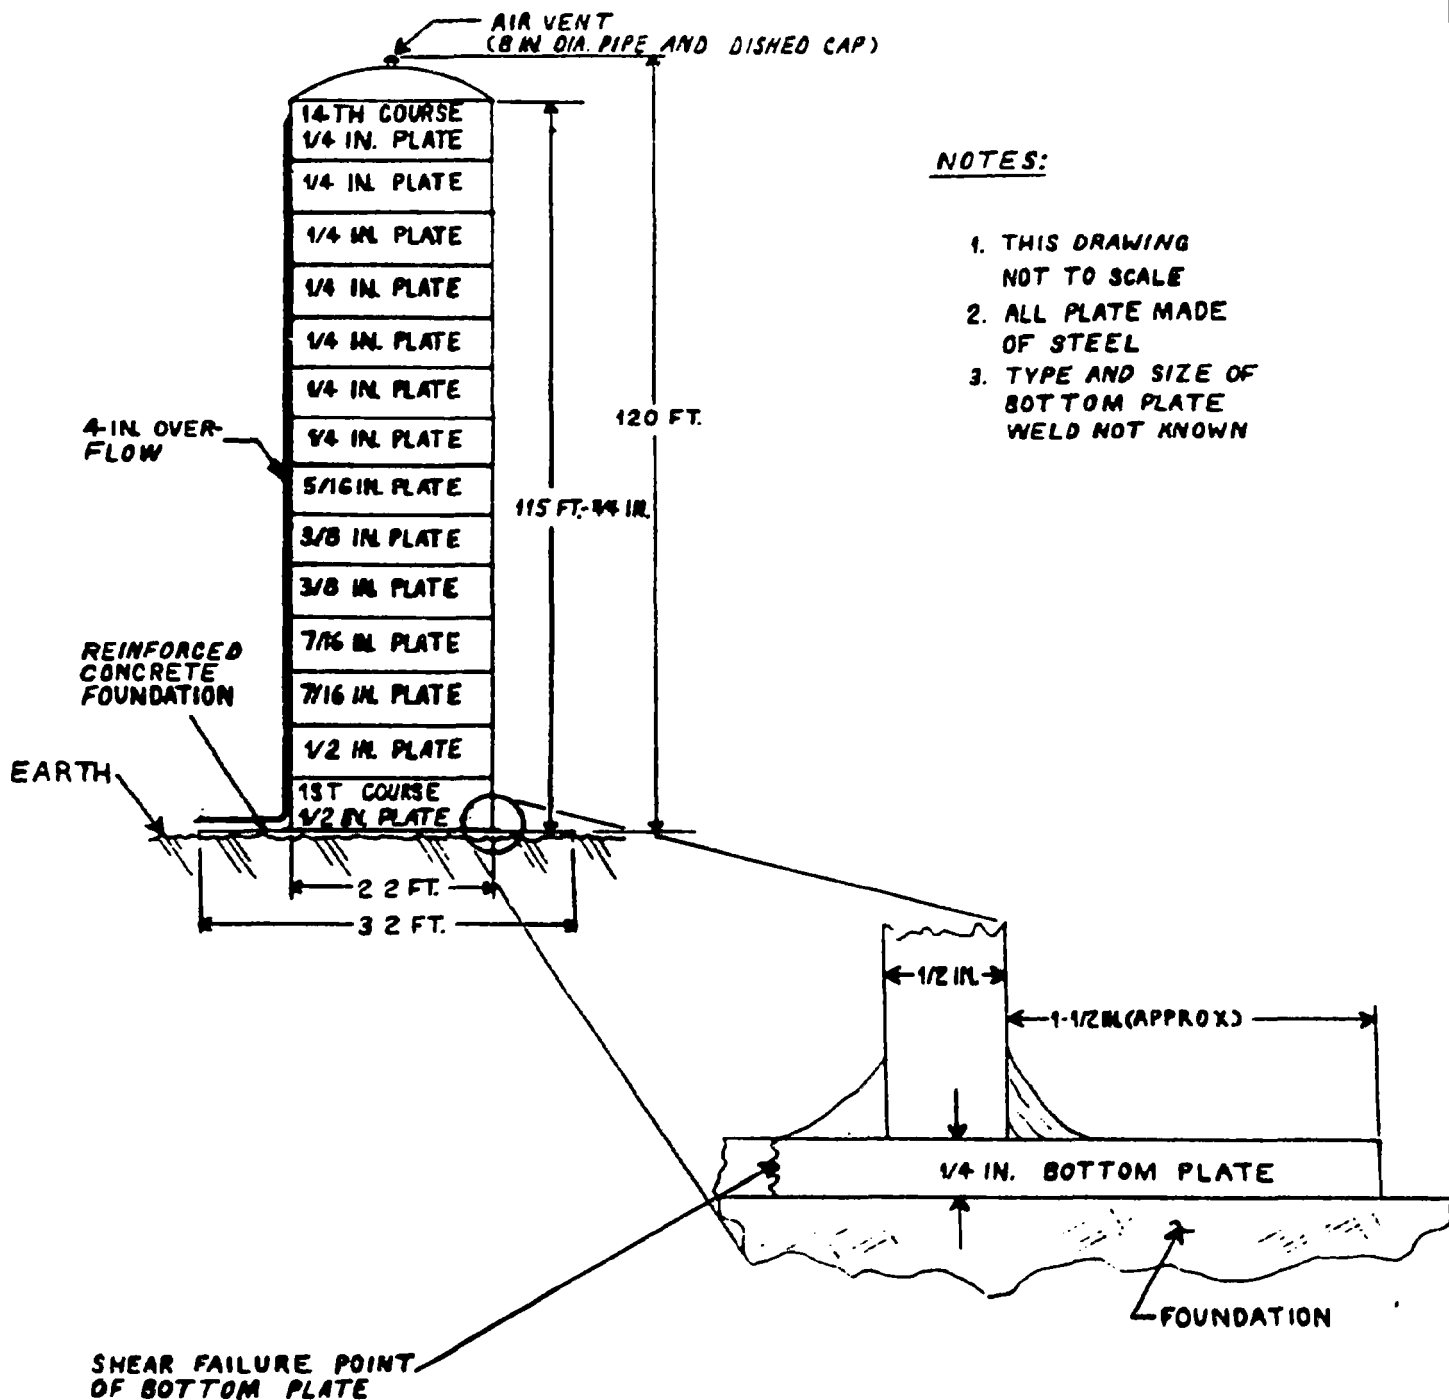
FIGURE 2. STANDPIPE CONSTRUCTION DETAILS

The walls of the standpipe had stood on a 1/4-inch thick bottom plate, and were welded to the plate to prevent leakage. This plate was previously mentioned and appears on the circular foundation in the photo. Figure 2, along with providing some detail of the overall structure, includes a cross-sectional view of the wall to bottom plate weld. As seen in the drawing, the tank wall was sealed to the bottom plate with welds on both sides. When the failure occurred, the bottom plate broke from the inside of the interior weld, as the drawing indicates. The circular part of the plate inside the tank stayed on the foundation, while the ring of plate outside the weld went with the rest of the tank. The part of the plate that stayed on the foundation was dished up along its southern edge, and flat along the northern edge. The wreckage of the tank shows that a rupture occurred at the base, and that another occurred midway up the tank.
